November
2008

Yampa River Structural Master Plan

Ecological Resource Consultants, Inc.

**City of
Steamboat Springs**

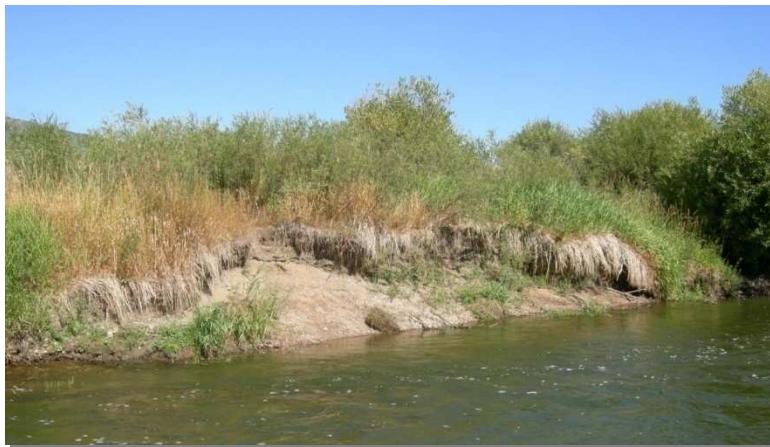
Photo 1- Existing Bank Stabilization AOI example

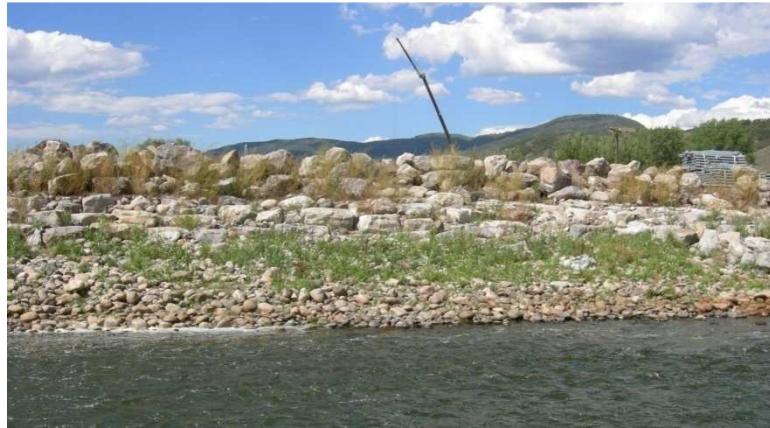
Photo 2 - Existing revetment

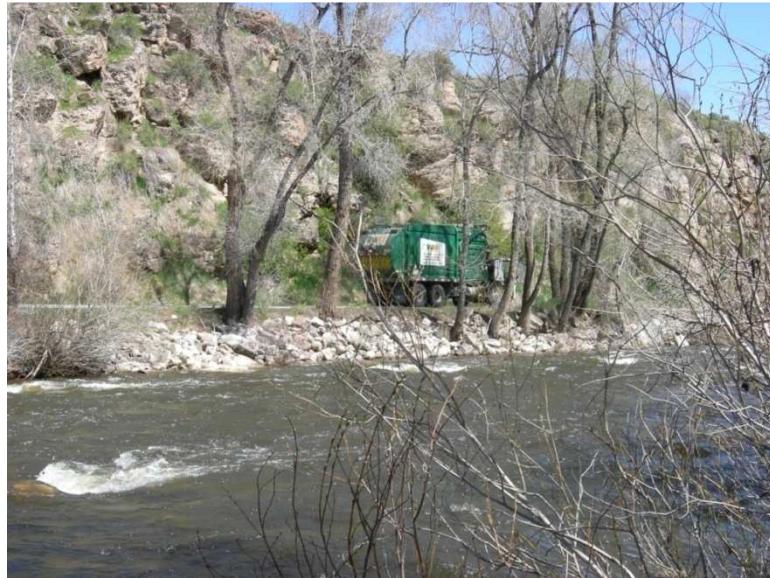
In many locations in the middle reaches, the railroad track or road lies along the top of the western bank and little to no buffer is present. The middle portion, through downtown, has lower vegetative quality with little to no buffer and less vegetation along the banks. In areas where bank instability has necessitated the installation of bank armoring little to no vegetation is present. The lack of riparian vegetation in these areas affects the overall health and function of the channel.

Photo 3- Lack of Riparian buffer and Vegetation Example

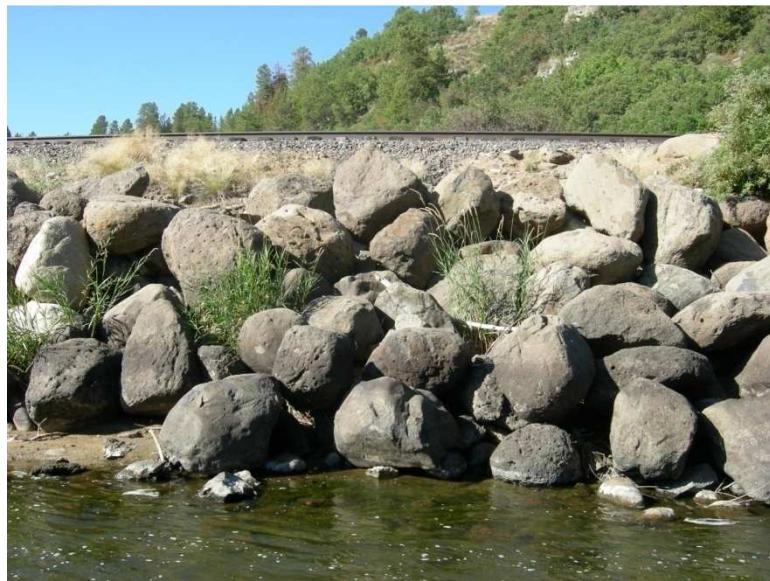
Photo 4 - Lack of Riparian buffer and Vegetation Example

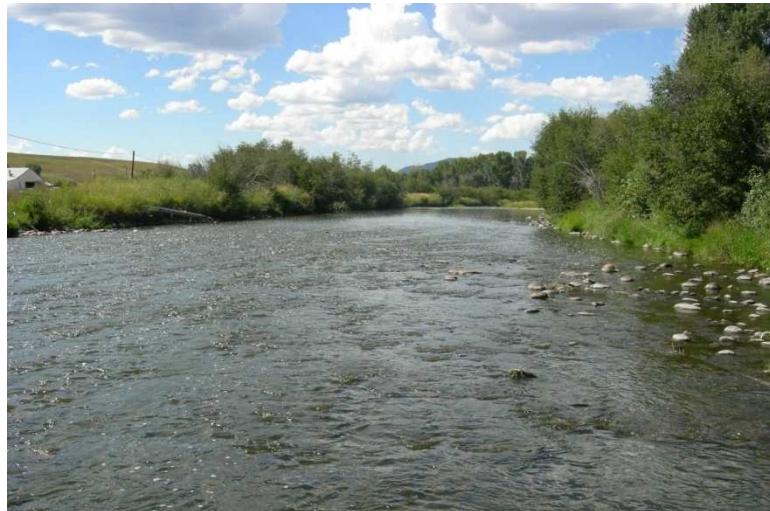
It is natural for a river to change its morphology in response to a disturbance. Following a channel altering disturbance the river typically undergoes a period of recovery in which the equilibrium of the channel is reestablished. For example, a channel that widens and straightens in response to a flood will narrow and regain sinuosity through revegetation and sediment transport. In the case of the River through much of the project reach, the degree of human impact is so great that the system is not capable of adapting to the forced changes. This is indicative of areas on the River where the channel is wide, straight and shallow with little or no pronounced thalweg.

Photo 5 - Overly wide and shallow channel

Given the development that has occurred in these areas, true channel restoration is not possible. ERC believes the goals for these areas should be to provide a level of channel equilibrium that is obtainable given current land constraints. Minor improvements can regain some of the natural function of the stream system which will lead to improved aquatic and riparian function and recreational opportunities.

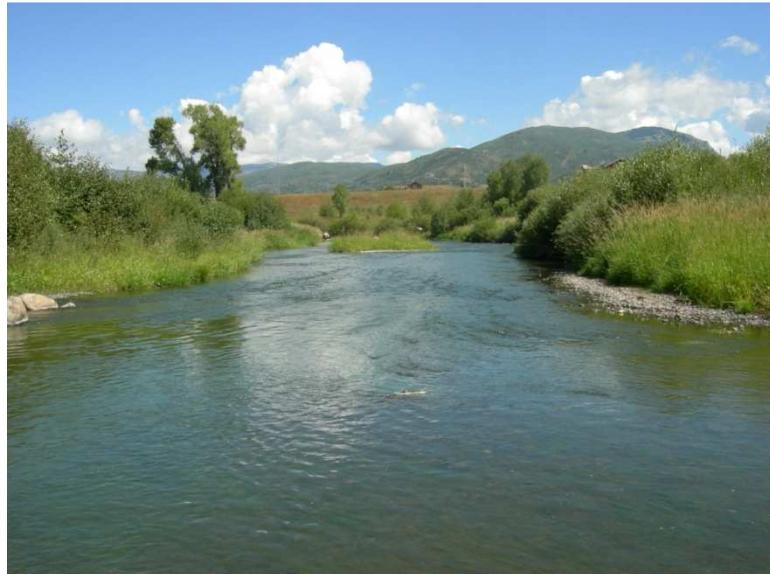
Photo 6 - Slackwater and braiding

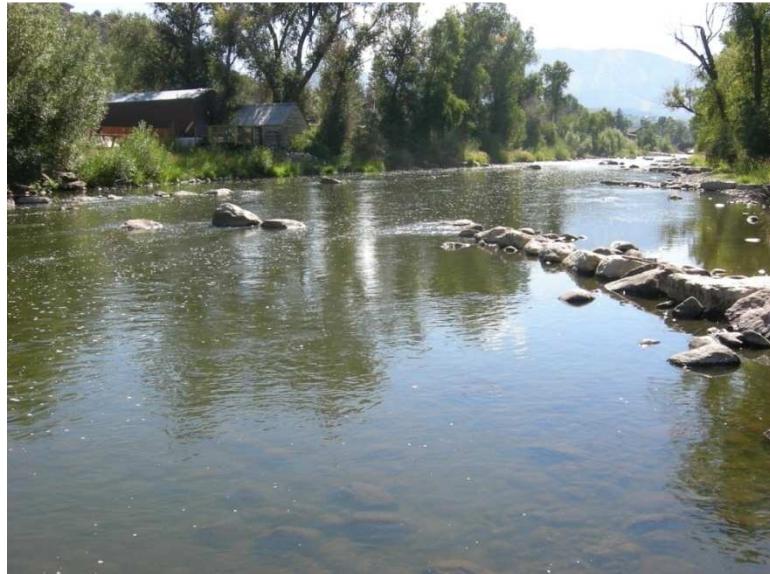
Photo 7 – Vanes have been used previously in an effort to create meanders and low flow water depths

ERC believes that the installation of vanes has benefited the stream by creating deeper water in some areas. However, in most cases the vanes as constructed have further aggravated the unnatural form of the channel.

Natural channels have a thread of the deepest water, called the thalweg, on the outside bend and shallower areas and bars on the inside of bends. This follows the natural stream process where channel material is eroded from an outside bend and deposited on an inside bend. In locations where vanes have been constructed along both banks the vanes are fighting this natural process and instead trying to structurally force flows down the center of the channel. This is generally not an optimal solution as the vanes further force the channel into a straight alignment and they are susceptible to failure as the natural forces of the channel are working against them.

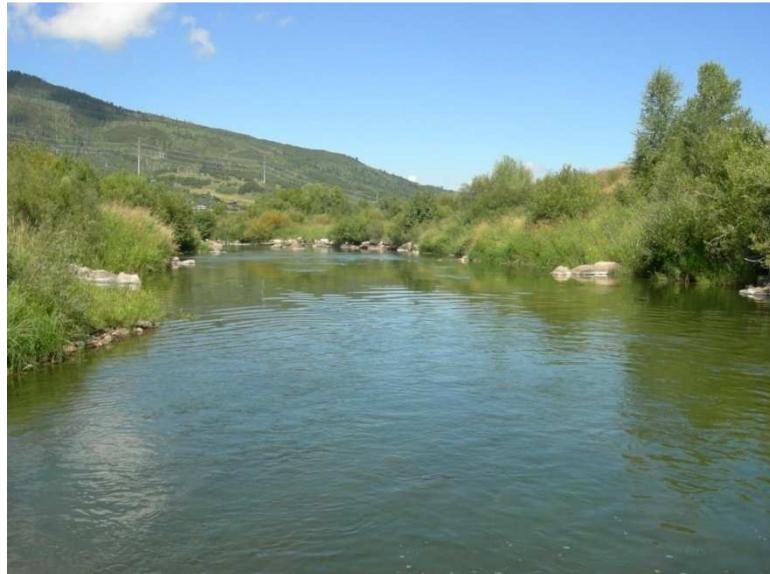
Photo 8 - Lack of aquatic habitat

There are many areas along the River where aquatic habitat is well below optimal. Overall a majority of the channel is dominated by low gradient riffles with limited deeper pools. Habitat variety is minimal through most of the project reach. In other areas little or no instream habitat exists.

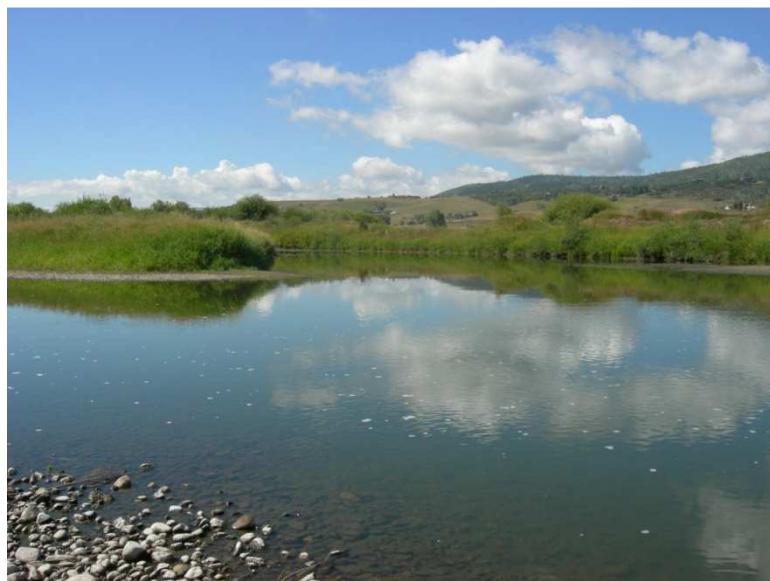
Photo 9 - Lack of aquatic habitat

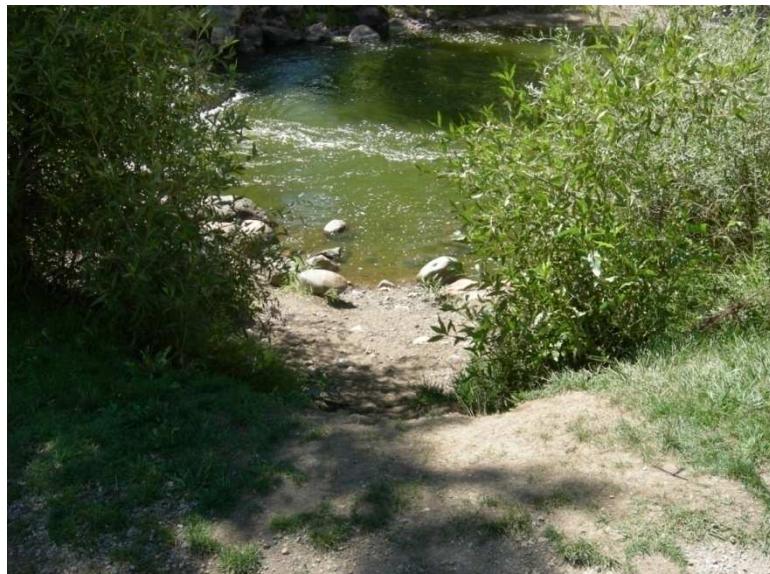
Photo 10 - Eroding access point at "The Beach" in Dr. Rich Weiss Park

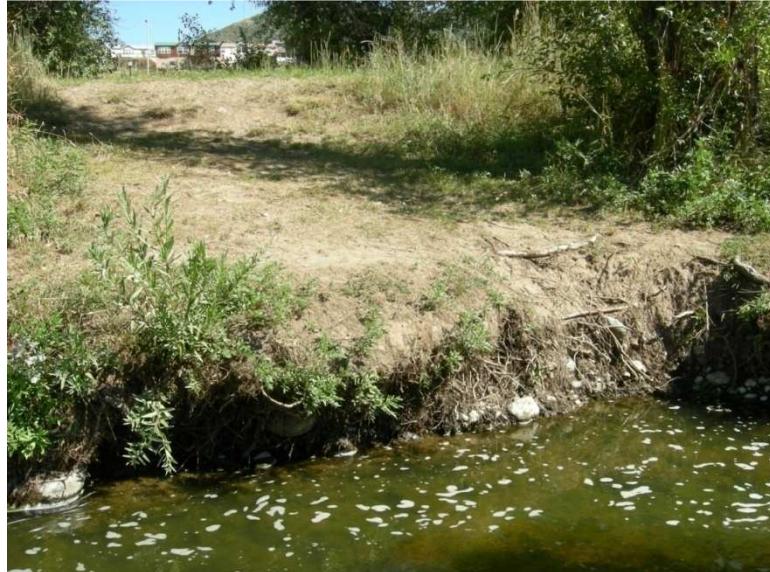
Photo 11 – Eroding Informal Access Point

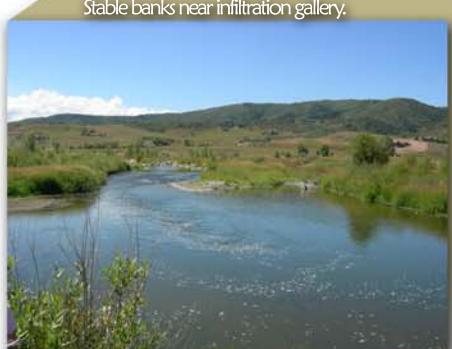
Stable banks near infiltration gallery.

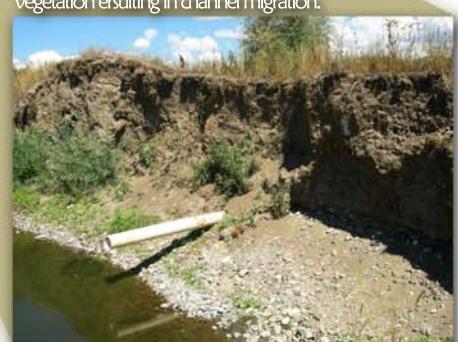
Bank erosion and limited riparian vegetation resulting in channel migration.
