November
2008

Yampa River Structural Master Plan

Ecological Resource Consultants, Inc.

**City of
Steamboat Springs**

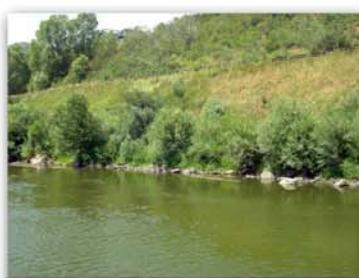
Limited buffer between road and channel.

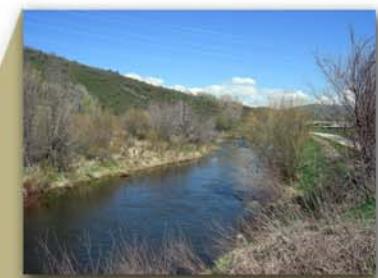
Side channel with good opportunities for improved aquatic habitat.

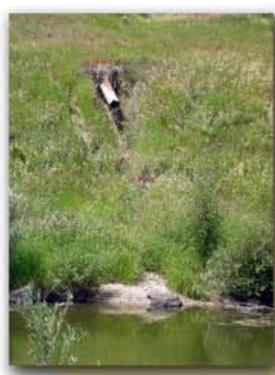
Stormwater discharge with downcutting and erosion.

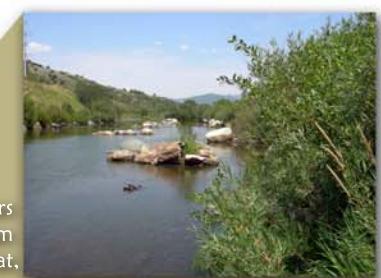
Boulder clusters provide instream aquatic habitat, but overall poor.

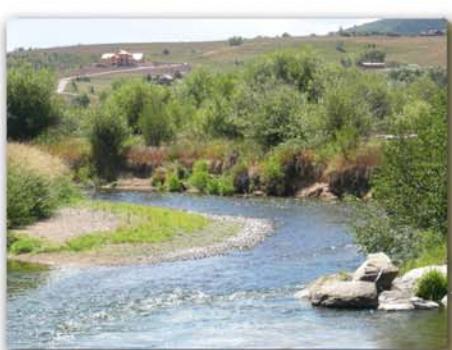
Bank erosion and debris

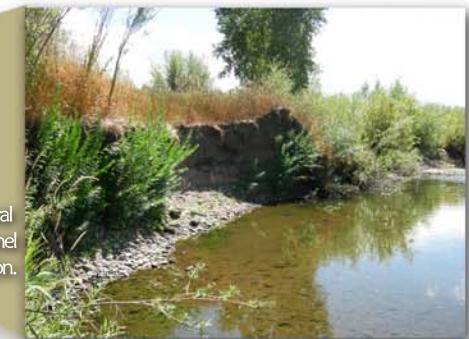
Lateral channel migration.

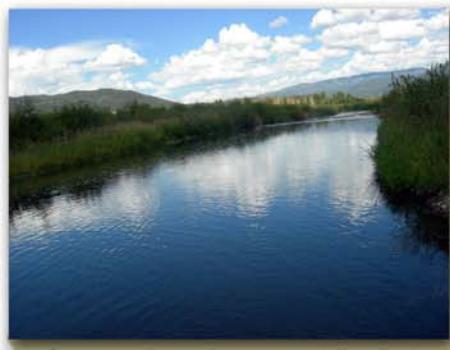
Stagnant channel area providing limited aquatic habitat.
